## DYNAMIC RESPONSES OF SIX MULTISTORY BUILDINGS DURING THE SAN FERNANDO EARTHQUAKE

By  
Douglas A. Foutch  
George W. Housner  
Paul C. Jennings

Report No. EERL 75-02

A Report on Research Conducted under Grants  
from the National Science Foundation and  
the Earthquake Research Affiliates Program  
at the California Institute of Technology

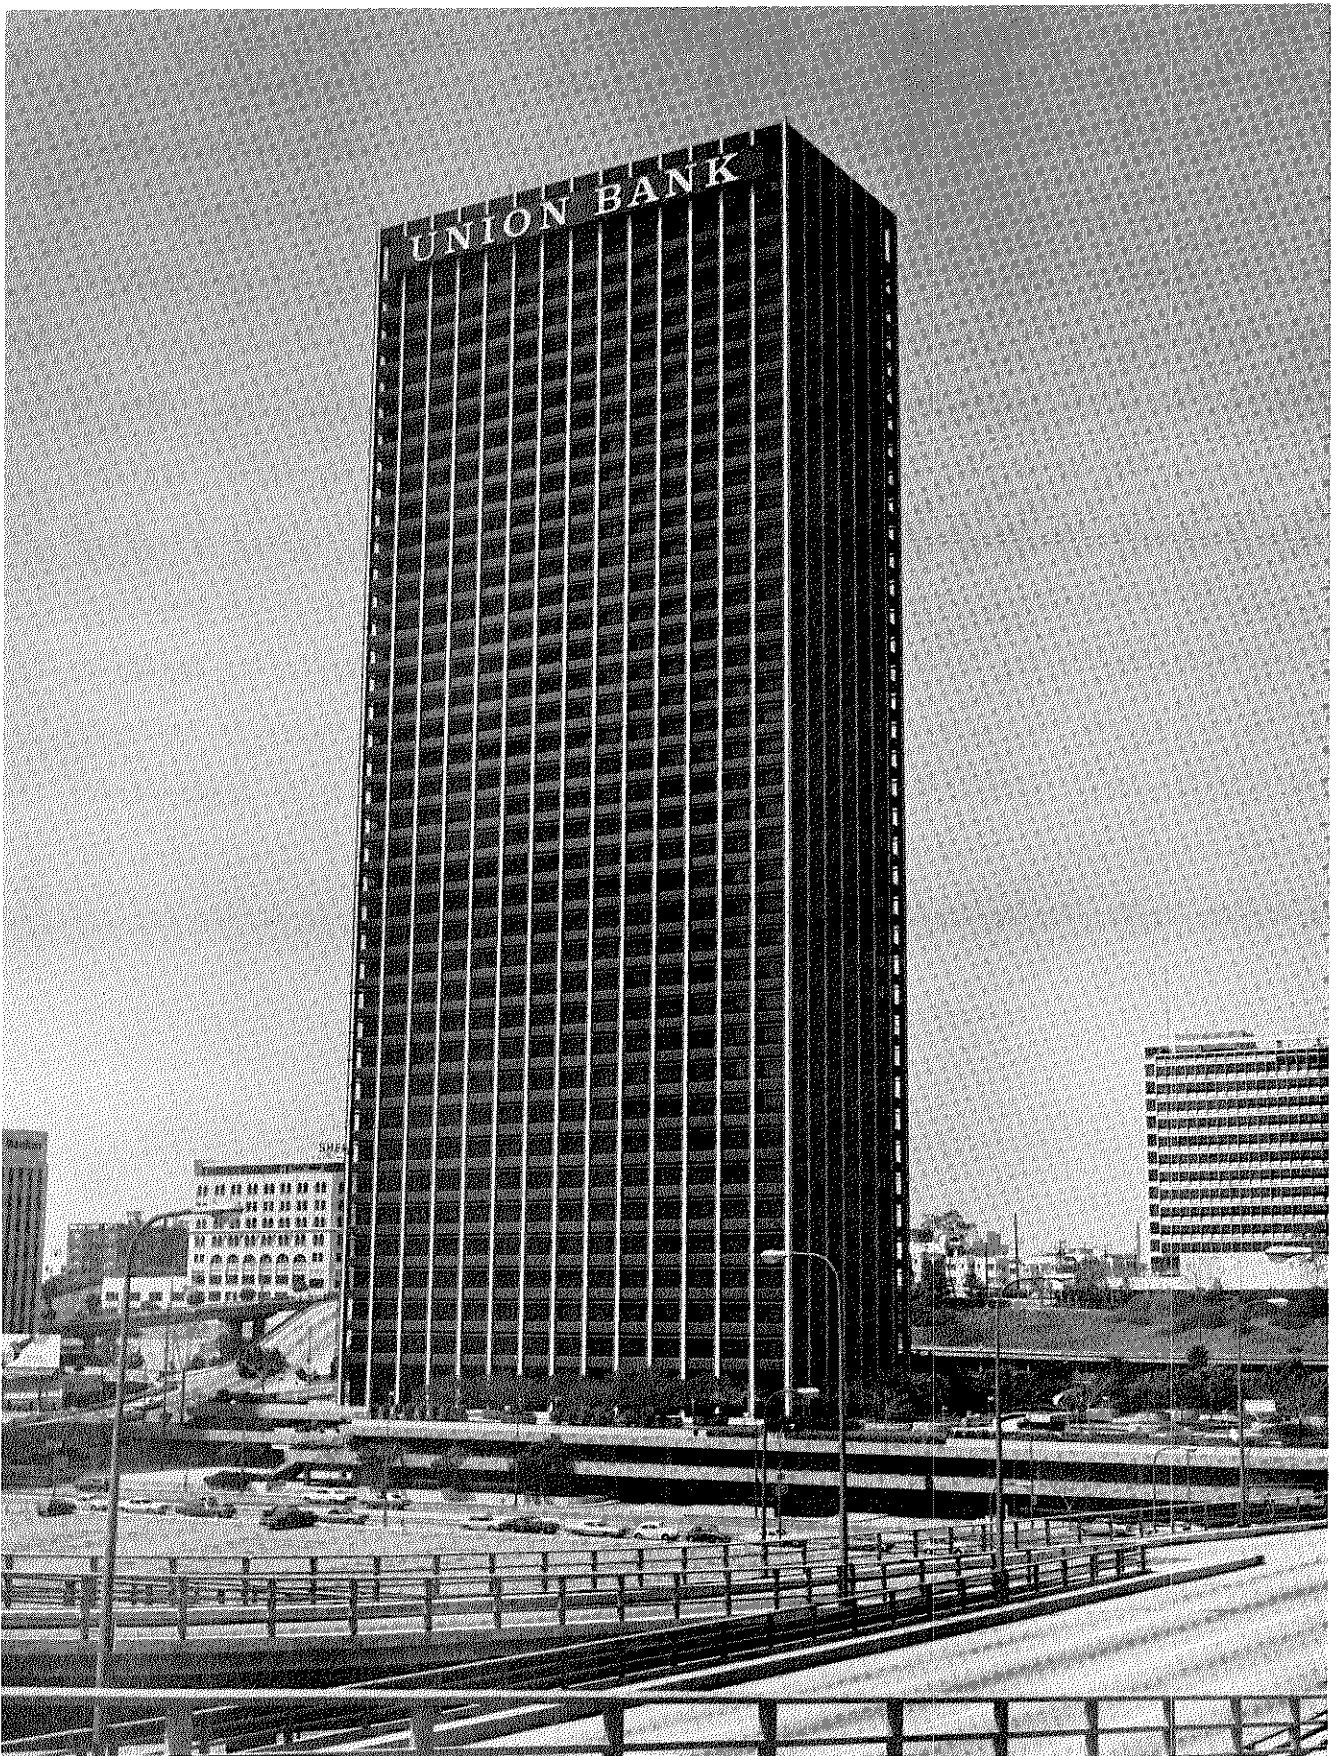
Figure 1.1 Union Bank Square

◆ - Location of Strong Motion Instruments

Union Bank Square is located in downtown Los Angeles, 21 miles south of the center of the San Fernando earthquake of February 9, 1971. The 42-story Union Bank building tower, which was designed in 1964, is 98 by 196 feet in plan and stands 535 feet above the second basement level and 496 feet, 39 stories, above the adjacent plaza level. The top floor contains air handling equipment and the two basement levels are used for storage, office services and parking. The street level is rental space and the remaining floors are used as offices. Figure 1.1 is a photograph of the east side of the Union Bank building. The building sustained only minor nonstructural damage during the earthquake, such as plaster cracking around the elevators and tile damage in the restrooms.

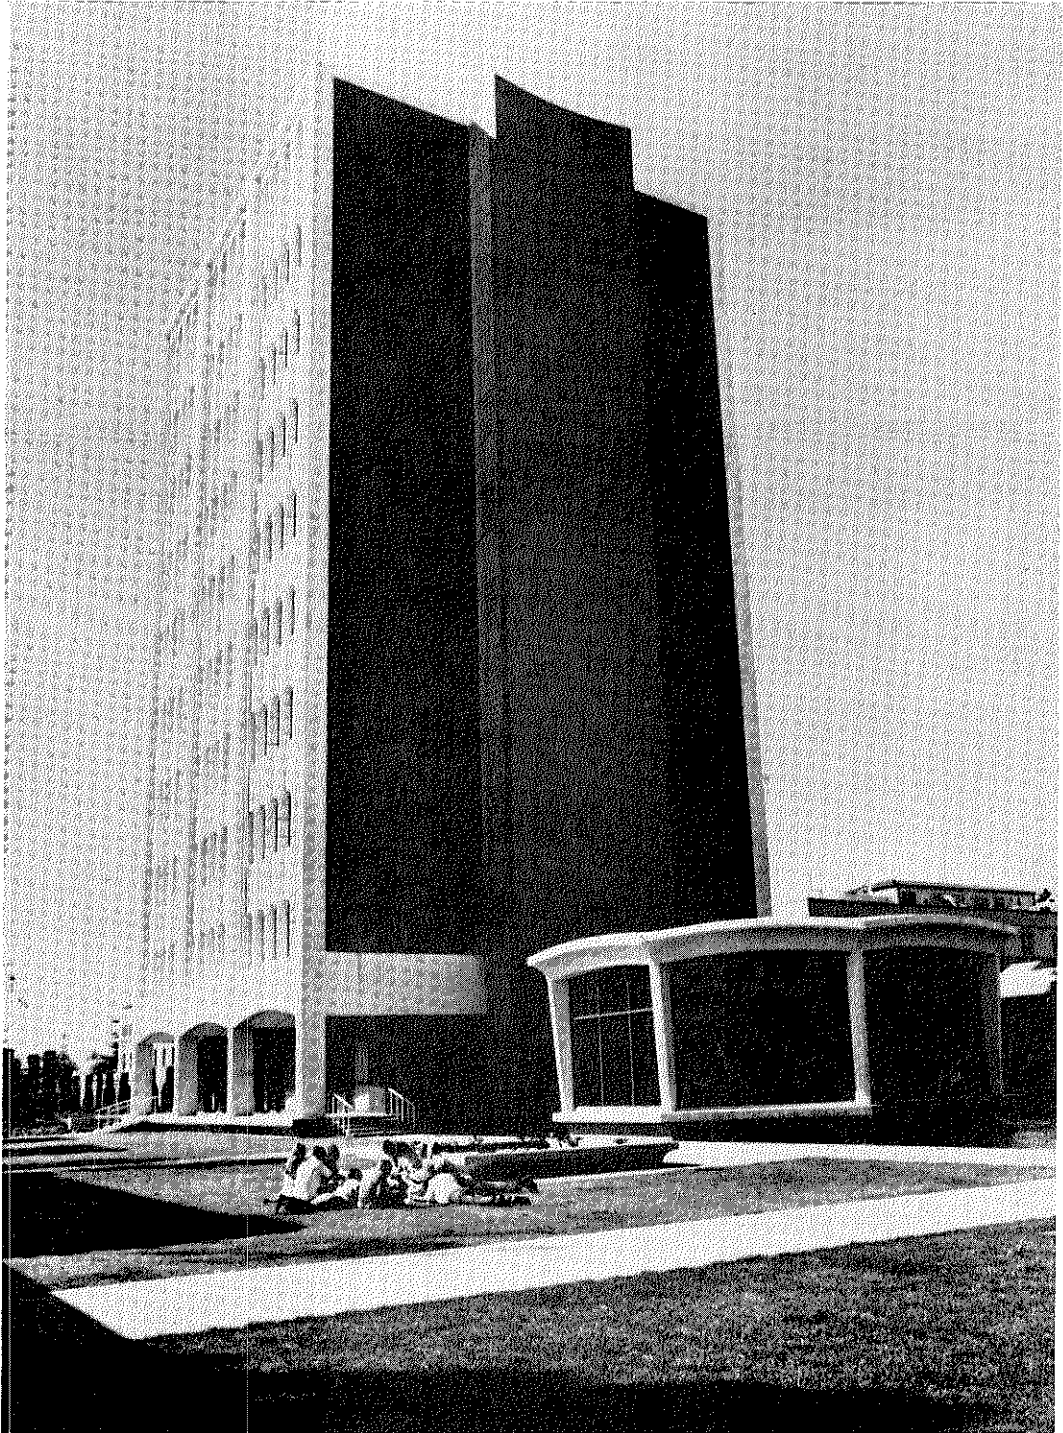
Figure 5.1 Millikan Library

The Robert Millikan Memorial Library building, located approximately 19 miles from the center of the San Fernando earthquake, is a nine-story reinforced concrete building constructed in 1966-1967 on the campus of the California Institute of Technology in Pasadena, California. The library building is 69 by 75 feet in plan and extends 144 feet above grade and 158 feet above the basement level. This includes an enclosed roof which houses air conditioning equipment. The basement through ninth floors provide library and office space. Except for the collapse of bookshelves and minor plaster cracking, the building suffered no damage. Figure 5.1 is a picture of the east elevation of Millikan Library.
